4. Post-tsunami survey of inundation area

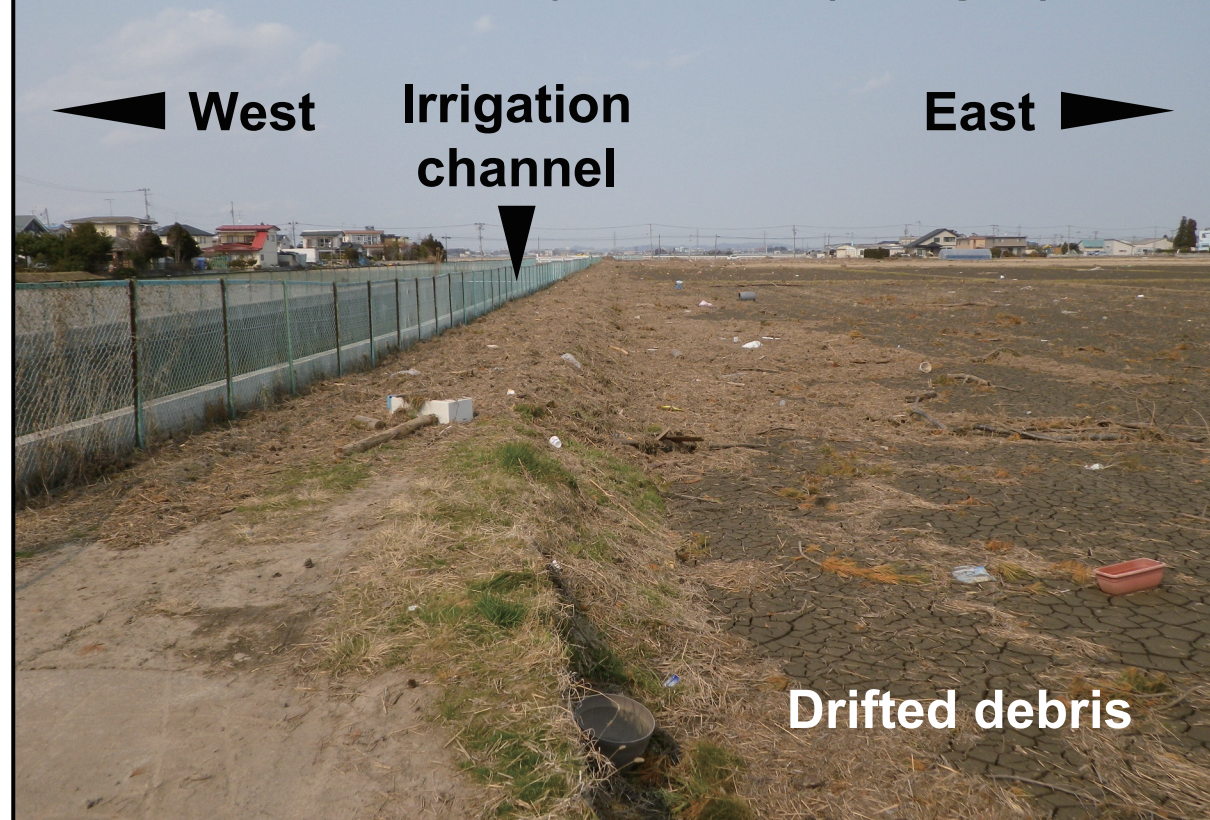
Photo 1: Limit of major run-up (in Fig. 2)

- Seaward migration of the coastline (~ 1 km since Jogan ages)
- Breakwaters and coastal forests
- Growth of the sand dunes due to the planting of coastal forests
- Sendai East Expressway (worked partly as breakwater)
- Irrigation channels parallel to the coast (Photo 1; border of major run-up by the 2011 event)

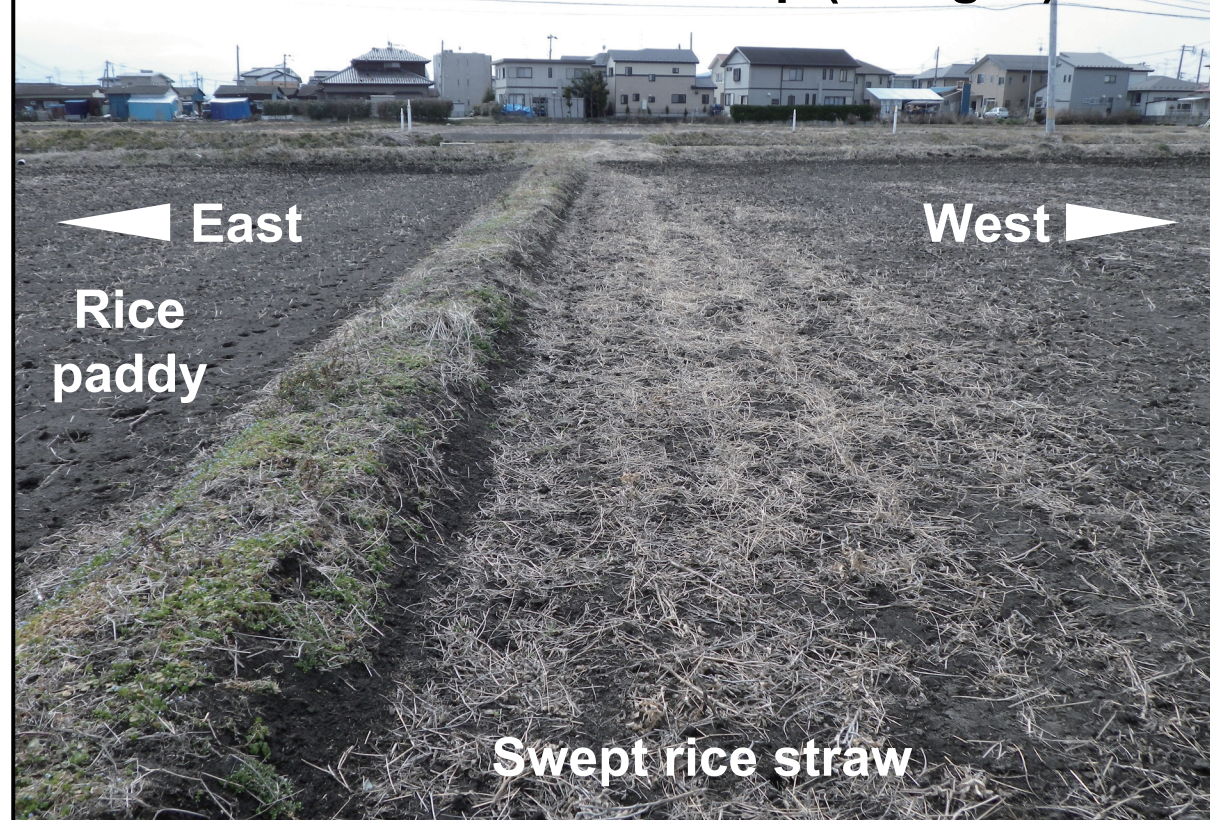
Photo 2: Limit of minor run-up (in Fig. 2)
